**DEPARTMENT OF ENVIRONMENTAL MANAGEMENT
INDIANAPOLIS****OFFICE MEMORANDUM**

SUBJECT: Trip Report for the OTH Inspection of Miller Plating & Metal Finishing LLC on August 8, 2008

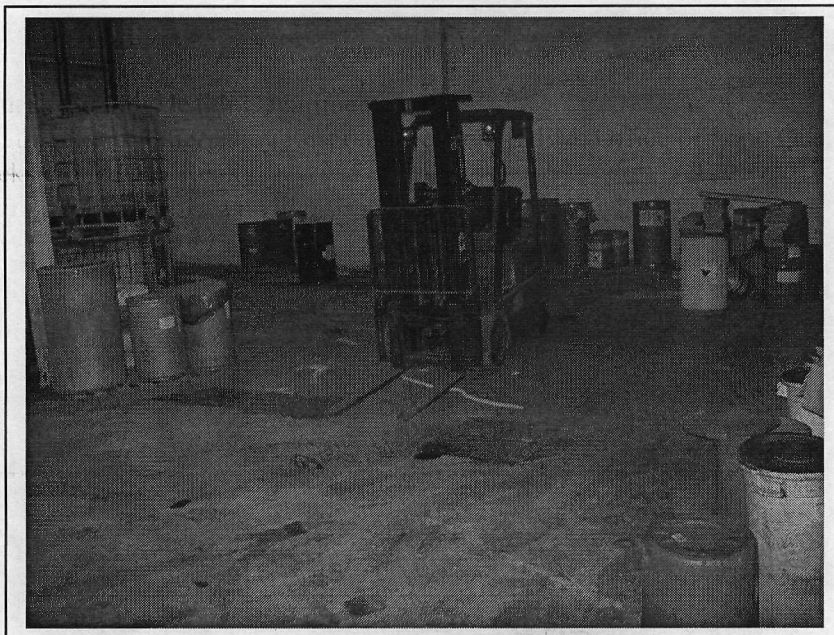
Description: Bankrupt/abandoned Miller Plating facility located at 3200 N. 6th Avenue, Evansville, Vanderburgh County, IN. EPA ID. IND006365985. Photo taken on 8/8/08, by Roger Wilson of IDEM's Industrial Waste Compliance Section 2 in the Chemical Storage Warehouse of the remaining chemicals in the Chemical Storage Area.

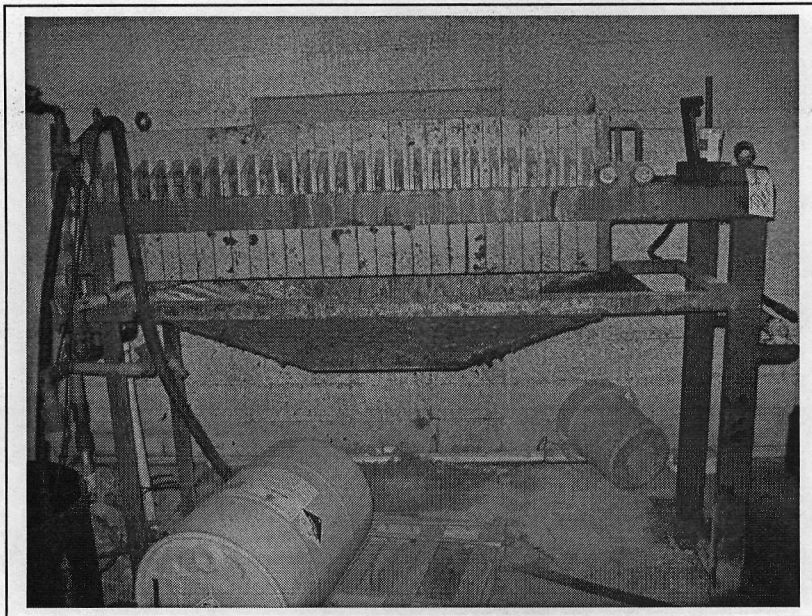
Description: Bankrupt/abandoned Miller Plating facility located at 3200 N. 6th Avenue, Evansville, Vanderburgh County, IN. EPA ID. IND006365985. Photo taken on 8/8/08, by Roger Wilson of IDEM's Industrial Waste Compliance Section 2 in the Chemical Storage Warehouse. at the Wastewater Treatment Filter Press F006 HW on floor.

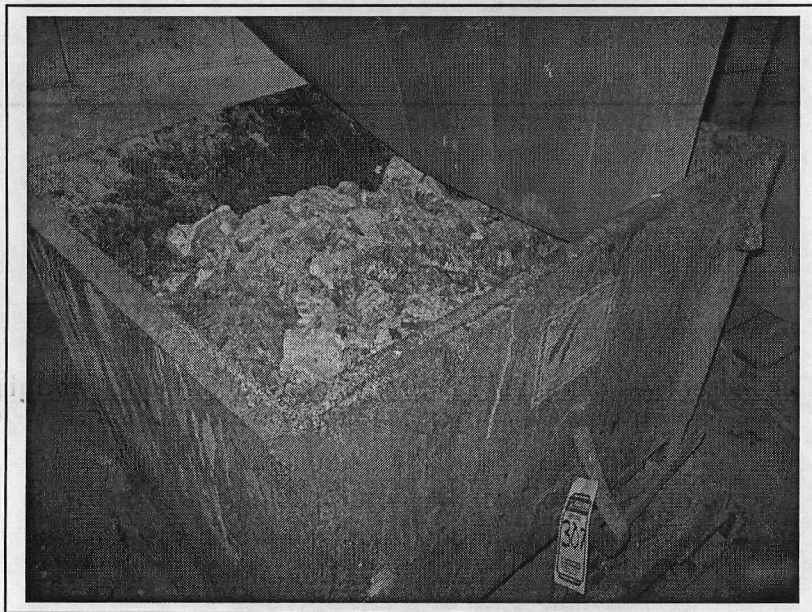
Description: Bankrupt/abandoned Miller Plating facility located at 3200 N. 6th Avenue, Evansville, Vanderburgh County, IN. EPA ID. IND006365985. Photo taken on 8/8/08, by Roger Wilson of IDEM's Industrial Waste Compliance Section 2 of Wastewater Treatment Filter Press Sludge HW F006 in Chemical Storage Warehouse.

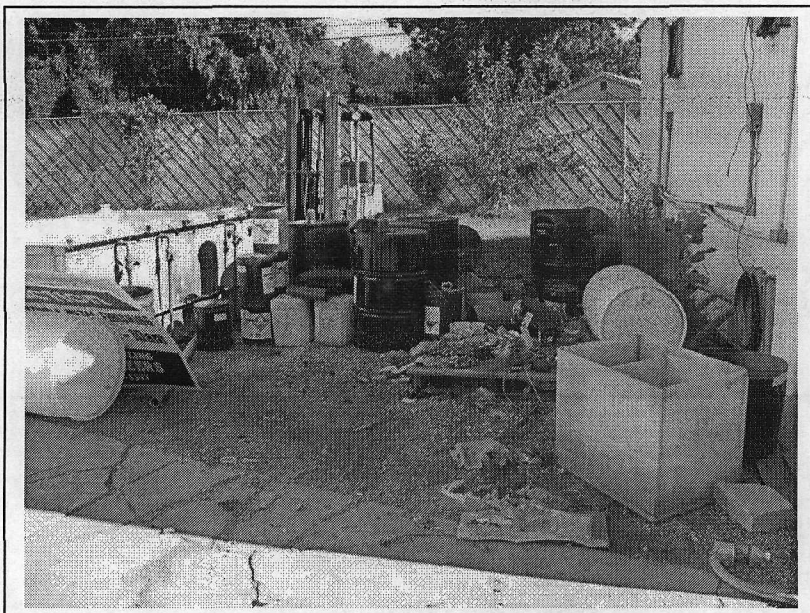
Description: Bankrupt/abandoned Miller Plating facility located at 3200 N. 6th Avenue, Evansville, Vanderburgh County, IN. EPA ID. IND006365985. Photo taken on 8/8/08, by Roger Wilson of IDEM's Industrial Waste Compliance Section 2 of empty containers rubbish, debris, and miscellaneous solid waste outside bldg.

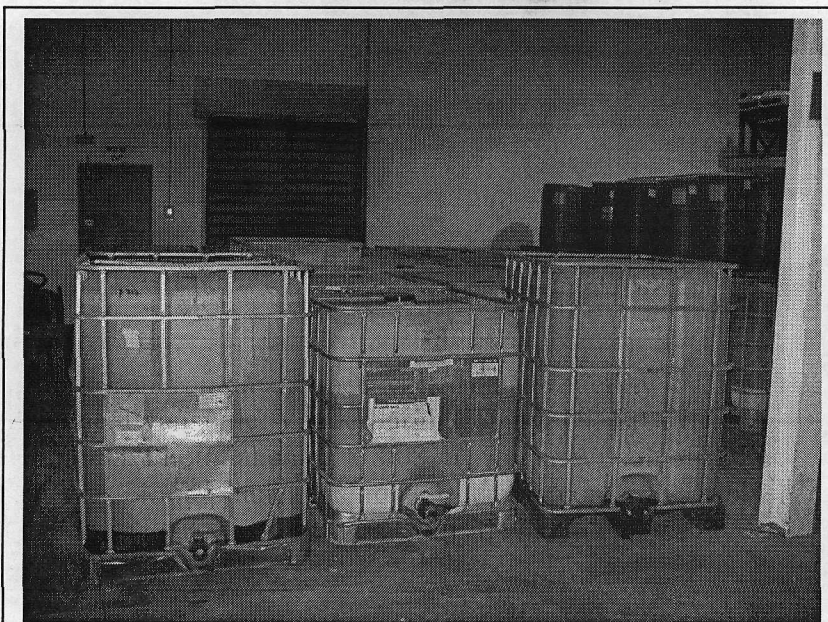
Description: Bankrupt/abandoned Miller Plating facility located at 3200 N. 6th Avenue, Evansville, Vanderburgh County, IN. EPA ID. IND006365985. Photo taken on 8/8/08, by Roger Wilson of IDEM's Industrial Waste Compliance Section 2 of HW stored in northwest side of main warehouse w/o HW labels and adequate aisle space.

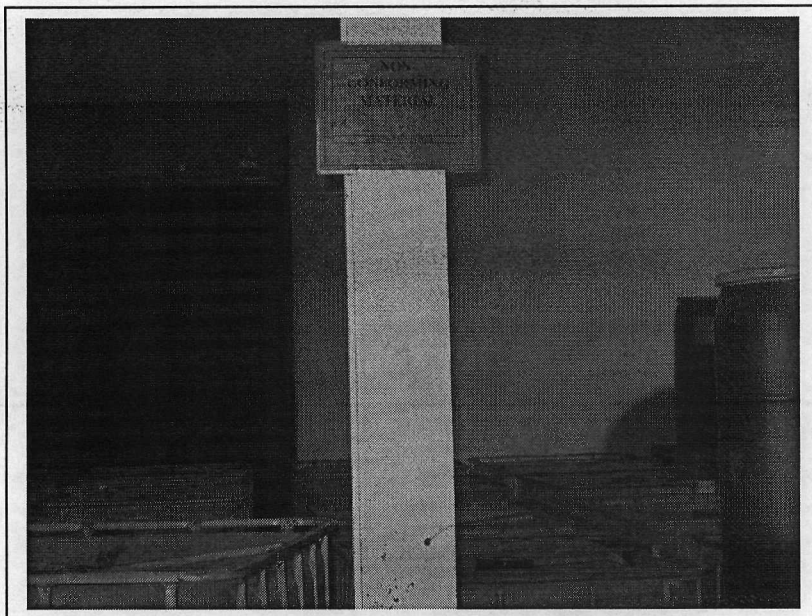
Description: Bankrupt/abandoned Miller Plating facility located at 3200 N. 6th Avenue, Evansville, Vanderburgh County, IN. EPA ID. IND006365985. Photo taken on 8/8/08, by Roger Wilson of IDEM's Industrial Waste Compliance Section 2 of HW stored in northwest side of main warehouse w/o HW labels and adequate aisle space.

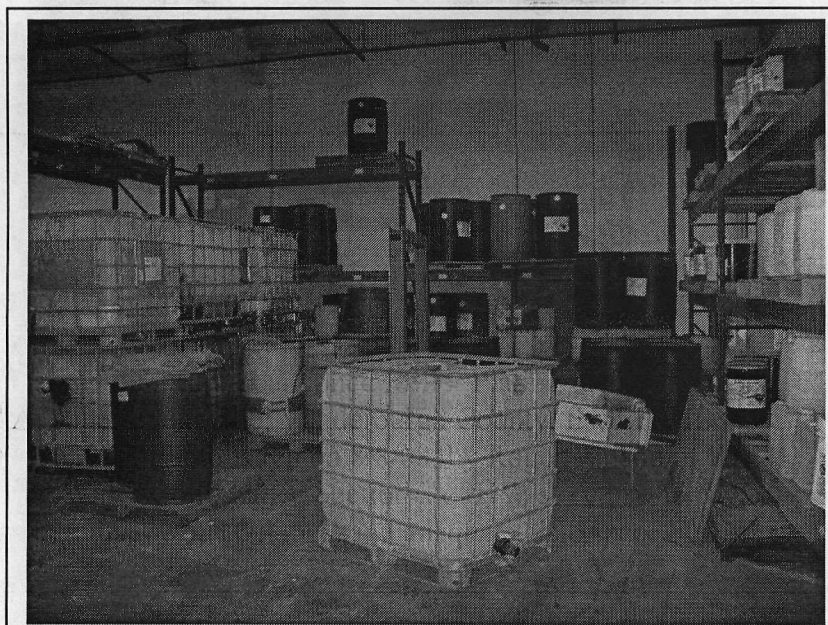
Description: Bankrupt/abandoned Miller Plating facility located at 3200 N. 6th Avenue, Evansville, Vanderburgh County, IN. EPA ID. IND006365985. Photo taken on 8/8/08, by Roger Wilson of IDEM's Industrial Waste Compliance Section 2 of chemical products remaining in the main warehouse storage area.

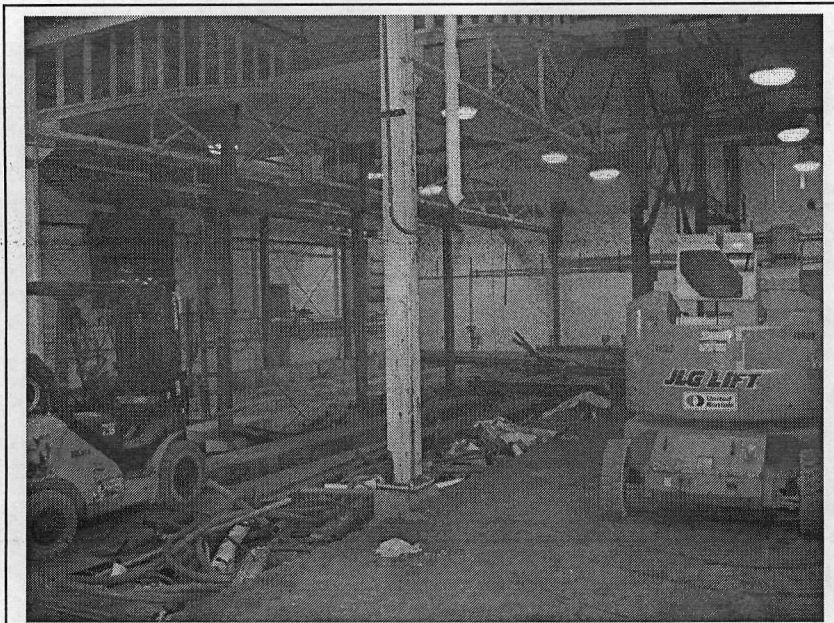
Description: Bankrupt/abandoned Miller Plating facility located at 3200 N. 6th Avenue, Evansville, Vanderburgh County, IN. EPA ID. IND006365985. Photo taken on 8/8/08, by Roger Wilson of IDEM's Industrial Waste Compliance Section 2 of Dept. 777 dismantling of electroplating line.

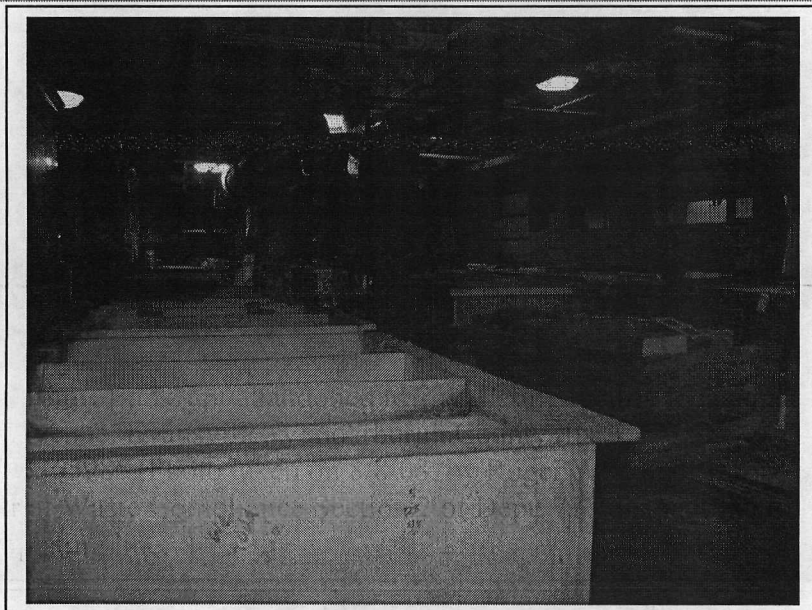
Description: Bankrupt/abandoned Miller Plating facility located at 3200 N. 6th Avenue, Evansville, Vanderburgh County, IN. EPA ID. IND006365985. Photo taken on 8/8/08, by Roger Wilson of IDEM's Industrial Waste Compliance Section 2 of Department 30 intact plating baths.

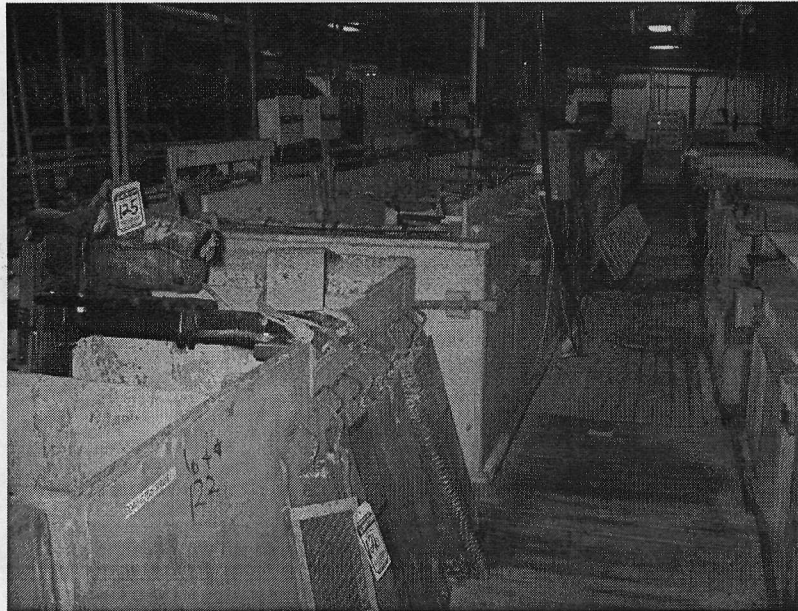
Description: Bankrupt/abandoned Miller Plating facility located at 3200 N. 6th Avenue, Evansville, Vanderburgh County, IN. EPA ID. IND006365985. Photo taken on 8/8/08, by Roger Wilson of IDEM's Industrial Waste Compliance Section 2 of the Department 40 plating line. The plating line and equipment/ chemicals in this area have not been sold.

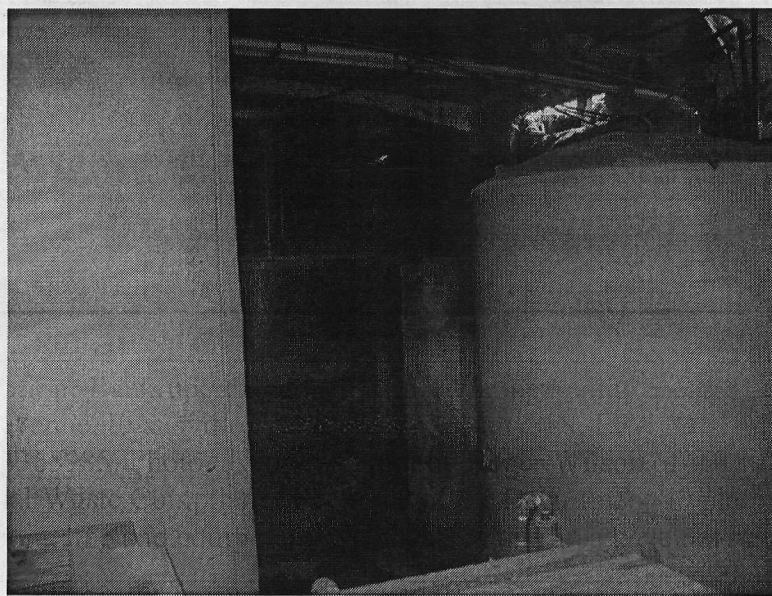
Description: Bankrupt/abandoned Miller Plating facility located at 3200 N. 6th Avenue, Evansville, Vanderburgh County, IN. EPA ID. IND006365985. Photo taken on 8/8/08, by Roger Wilson of IDEM's Industrial Waste Compliance Section 2 of the Wastewater Treatment Room and WWT tanks.

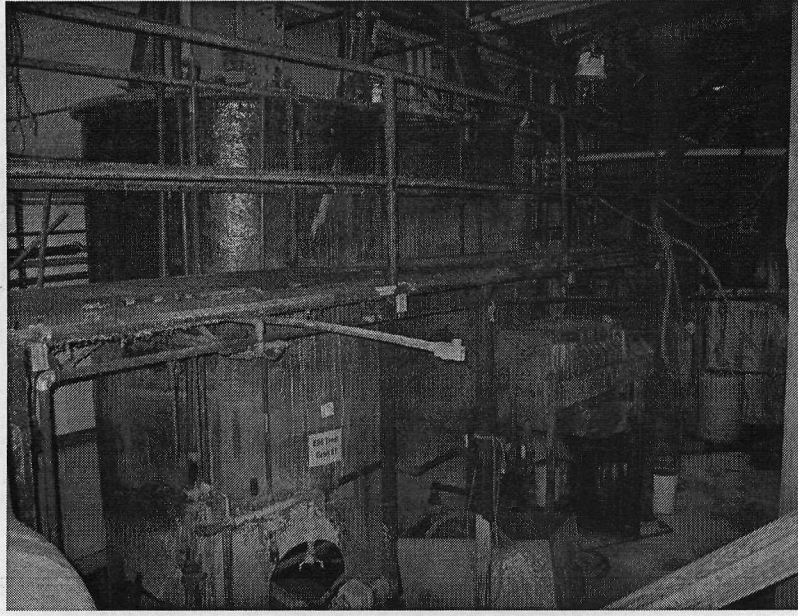
Description: Bankrupt/abandoned Miller Plating facility located at 3200 N. 6th Avenue, Evansville, Vanderburgh County, IN. EPA ID. IND006365985. Photo taken on 8/8/08, by Roger Wilson of IDEM's Industrial Waste Compliance Section 2 of the Wastewater Treatment Room and WWT tanks and miscellaneous equipment.

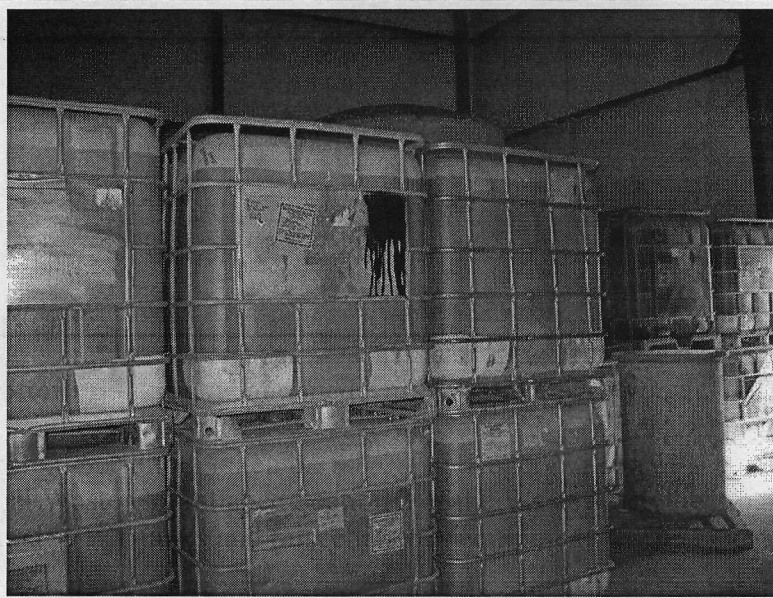
Description: Bankrupt/abandoned Miller Plating facility located at 3200 N. 6th Avenue, Evansville, Vanderburgh County, IN. EPA ID. IND006365985. Photo taken on 8/8/08, by Roger Wilson of IDEM's Industrial Waste Compliance Section 2 of hazardous waste stored in the Cyanide Storage Building in containers and tanks.

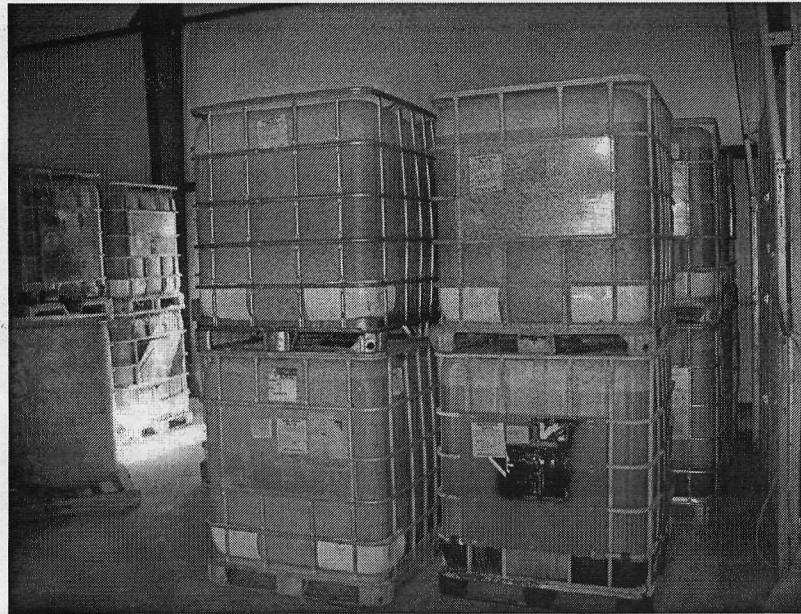
Description: Bankrupt/abandoned Miller Plating facility located at 3200 N. 6th Avenue, Evansville, Vanderburgh County, IN. EPA ID. IND006365985. Photo taken on 8/8/08, by Roger Wilson of IDEM's Industrial Waste Compliance Section 2 of hazardous waste stored in the Cyanide Storage Building in containers.

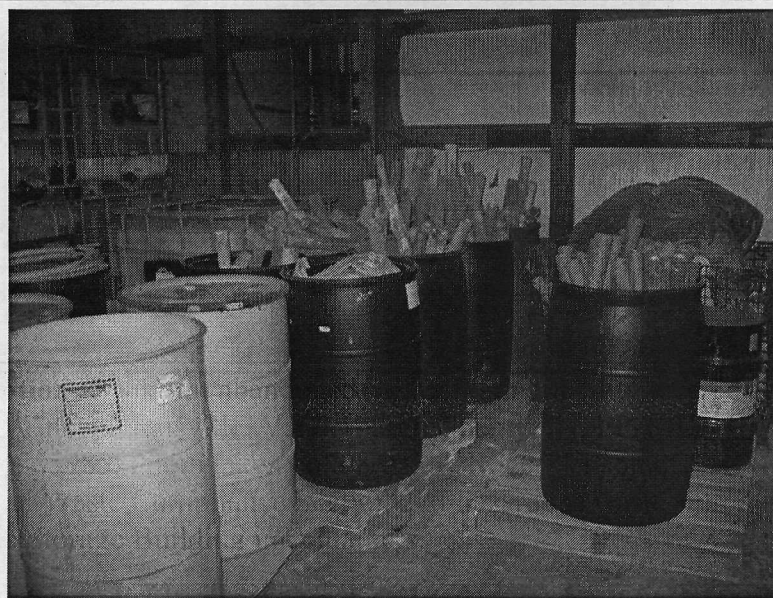
Description: Bankrupt/abandoned Miller Plating facility located at 3200 N. 6th Avenue, Evansville, Vanderburgh County, IN. EPA ID. IND006365985. Photo taken on 8/8/08, by Roger Wilson of IDEM's Industrial Waste Compliance Section 2 of open and unlabeled containers of hazardous waste in the Chemical Warehouse Storage Area.
